Weasler Over Running Clutch Used on Discbines

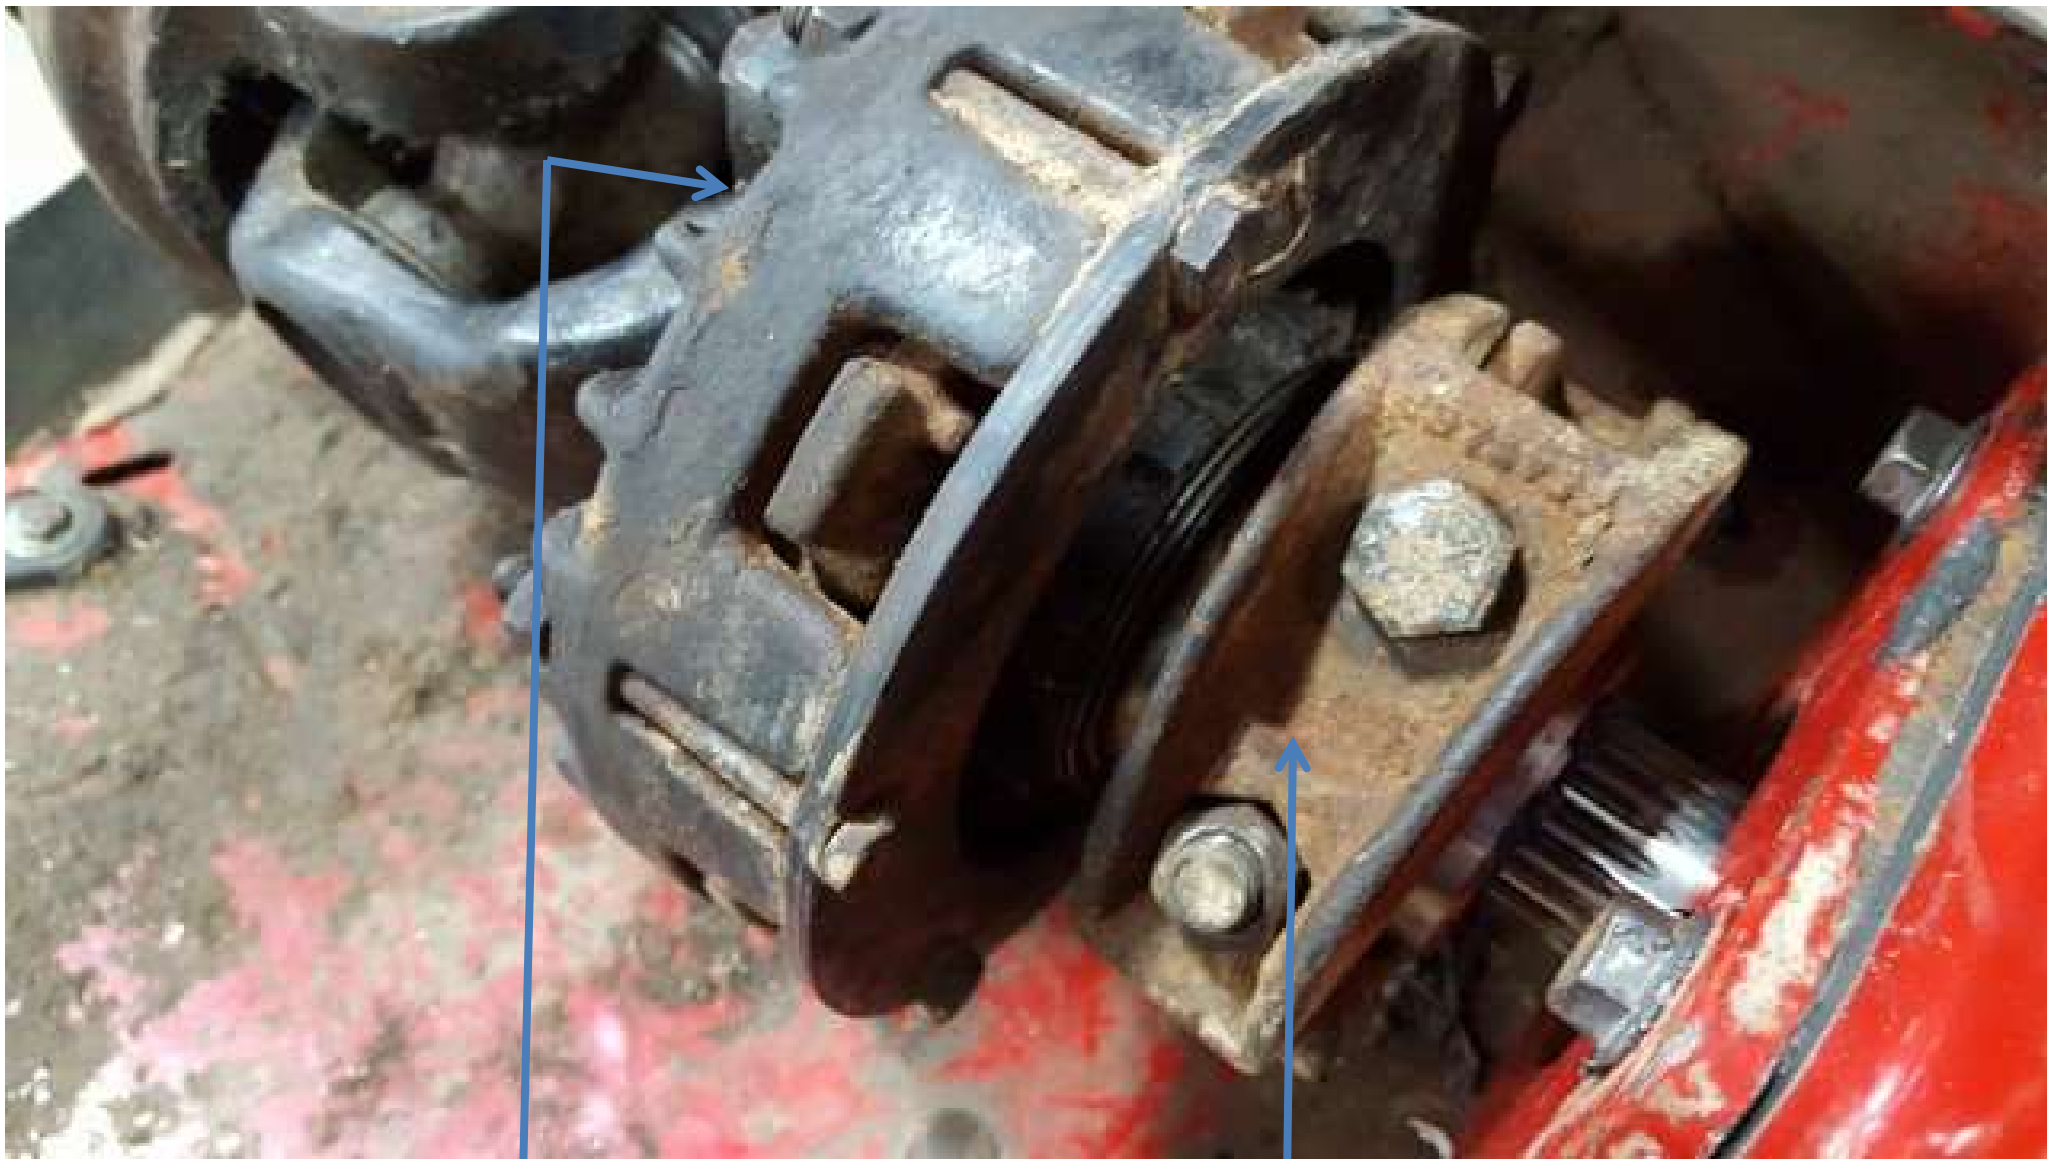
The Weasler drive line on 10 ft machines was used from around 1998 until 2006 and then again from 2014 to present. For the most part, the over running clutch is a dependable component. The most common problem being the over running clutch does not over run and is locked. When this happens the centrifugal force of the machine is transferred to the tractors pto clutch brake when the pto is shut off. This can damage the brake components of the tractor and cause excessive wear of the brake. I also believe some vibration issues can be caused by worn balls used in retaining the clutch center hub to the secondary drive shaft.

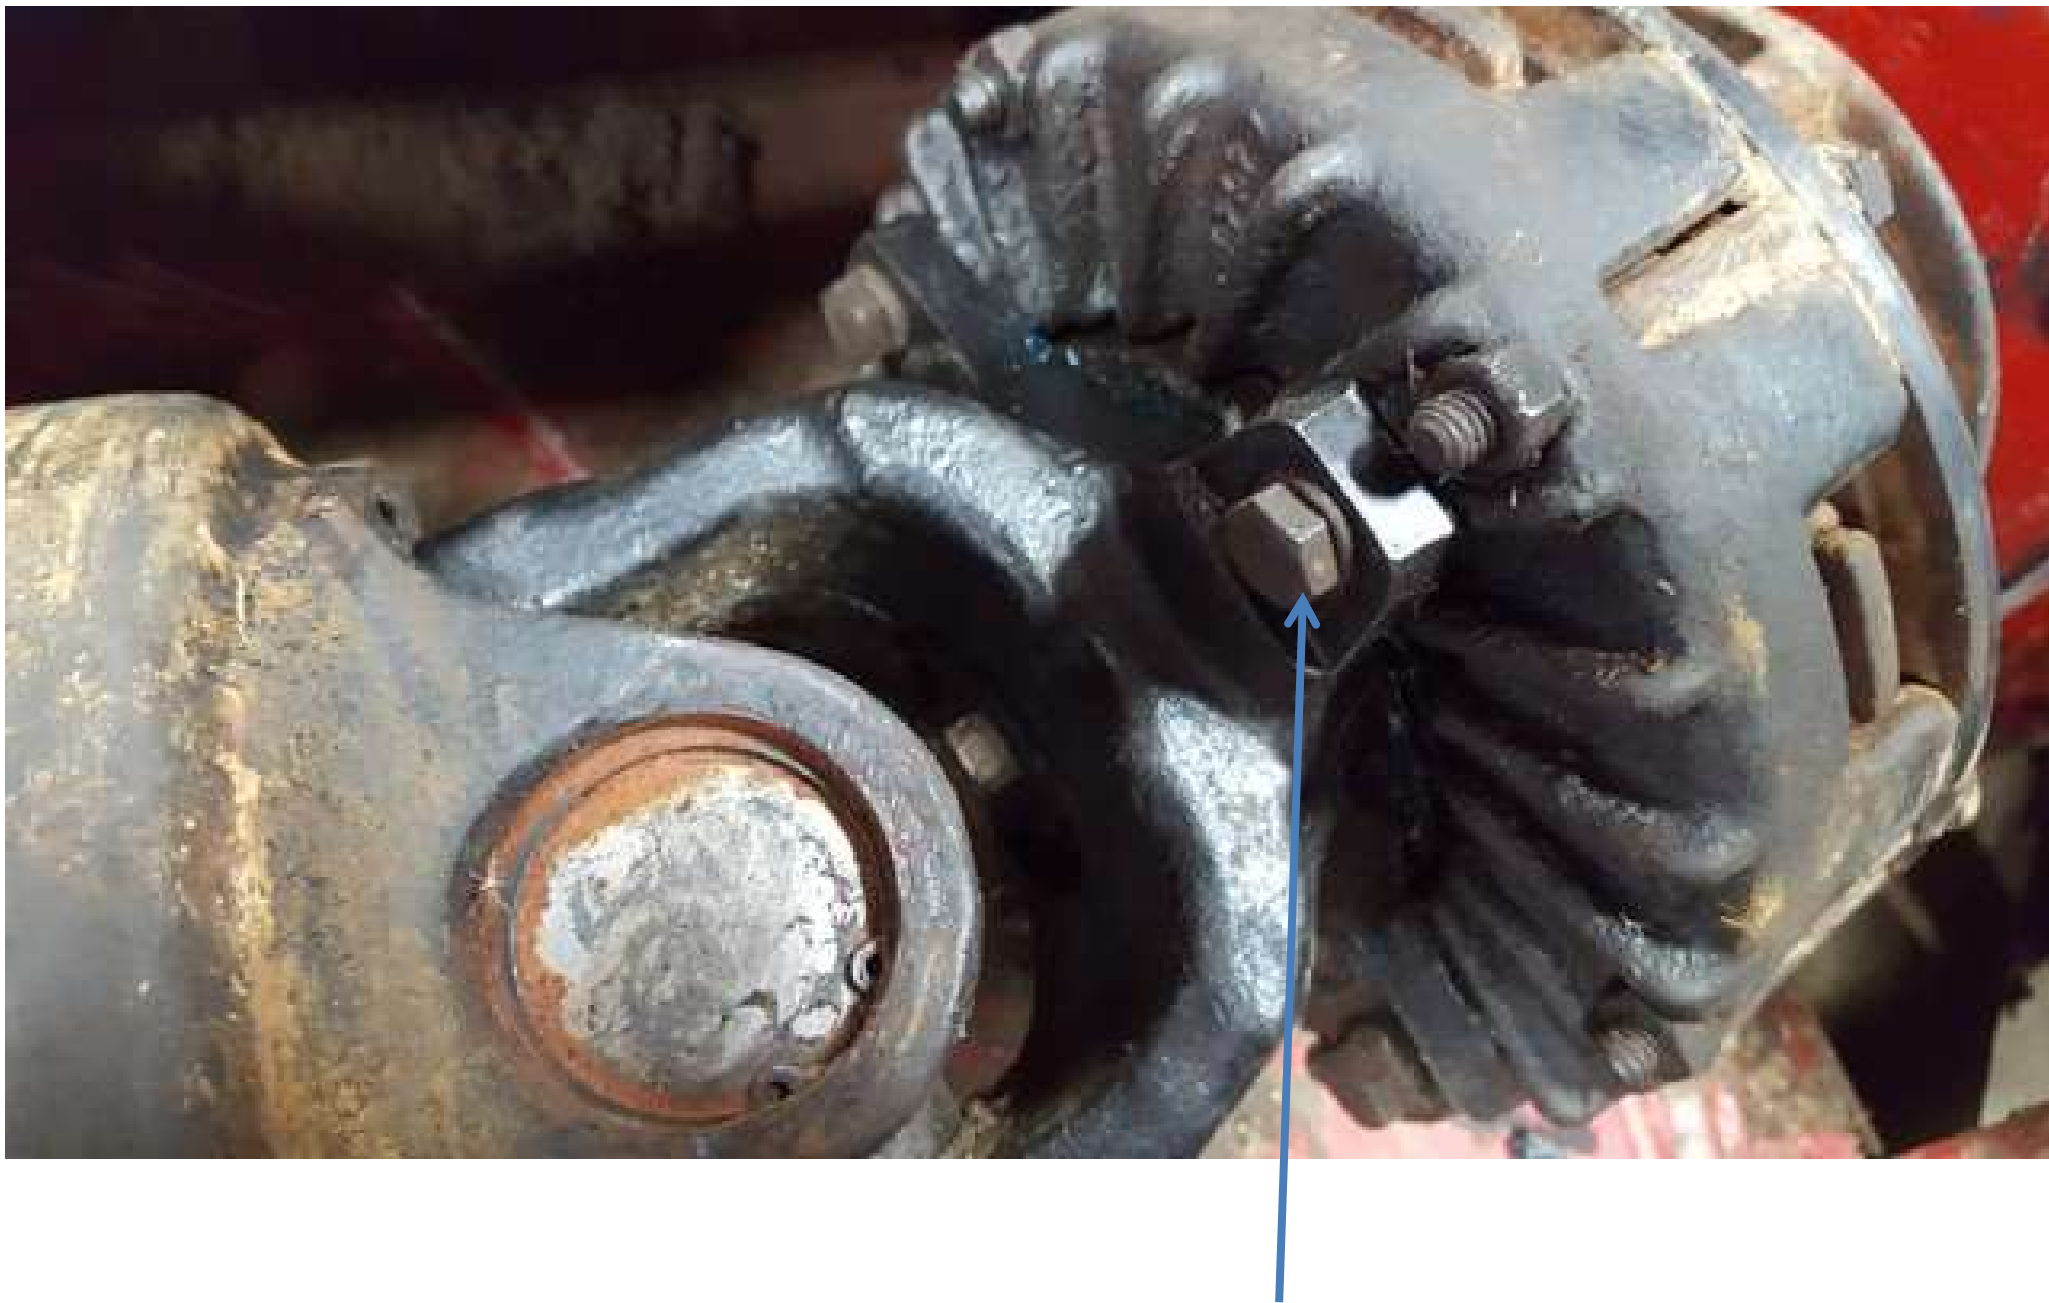
Bolt location on early machines

Clamp

The bevel gearbox input shaft on early machines had a tapered end to match the taper of the hub. These machines used a $\frac{1}{2}$ " bolt screwed in from the front to pull the hub tight on the gearbox shaft. Since the tapers pull tightly together, it will take a jar from a hammer and heavy shaft to free the taper so the clutch assembly can be removed. 2014 and newer machines use a straight splined gearbox input shaft and thus no bolt in the front. All use some type of clamp to clamp the rear of the hub to the gearbox shaft. You could see a clamp like this or on early models there will be blocks welded to the hub that the bolts go through.

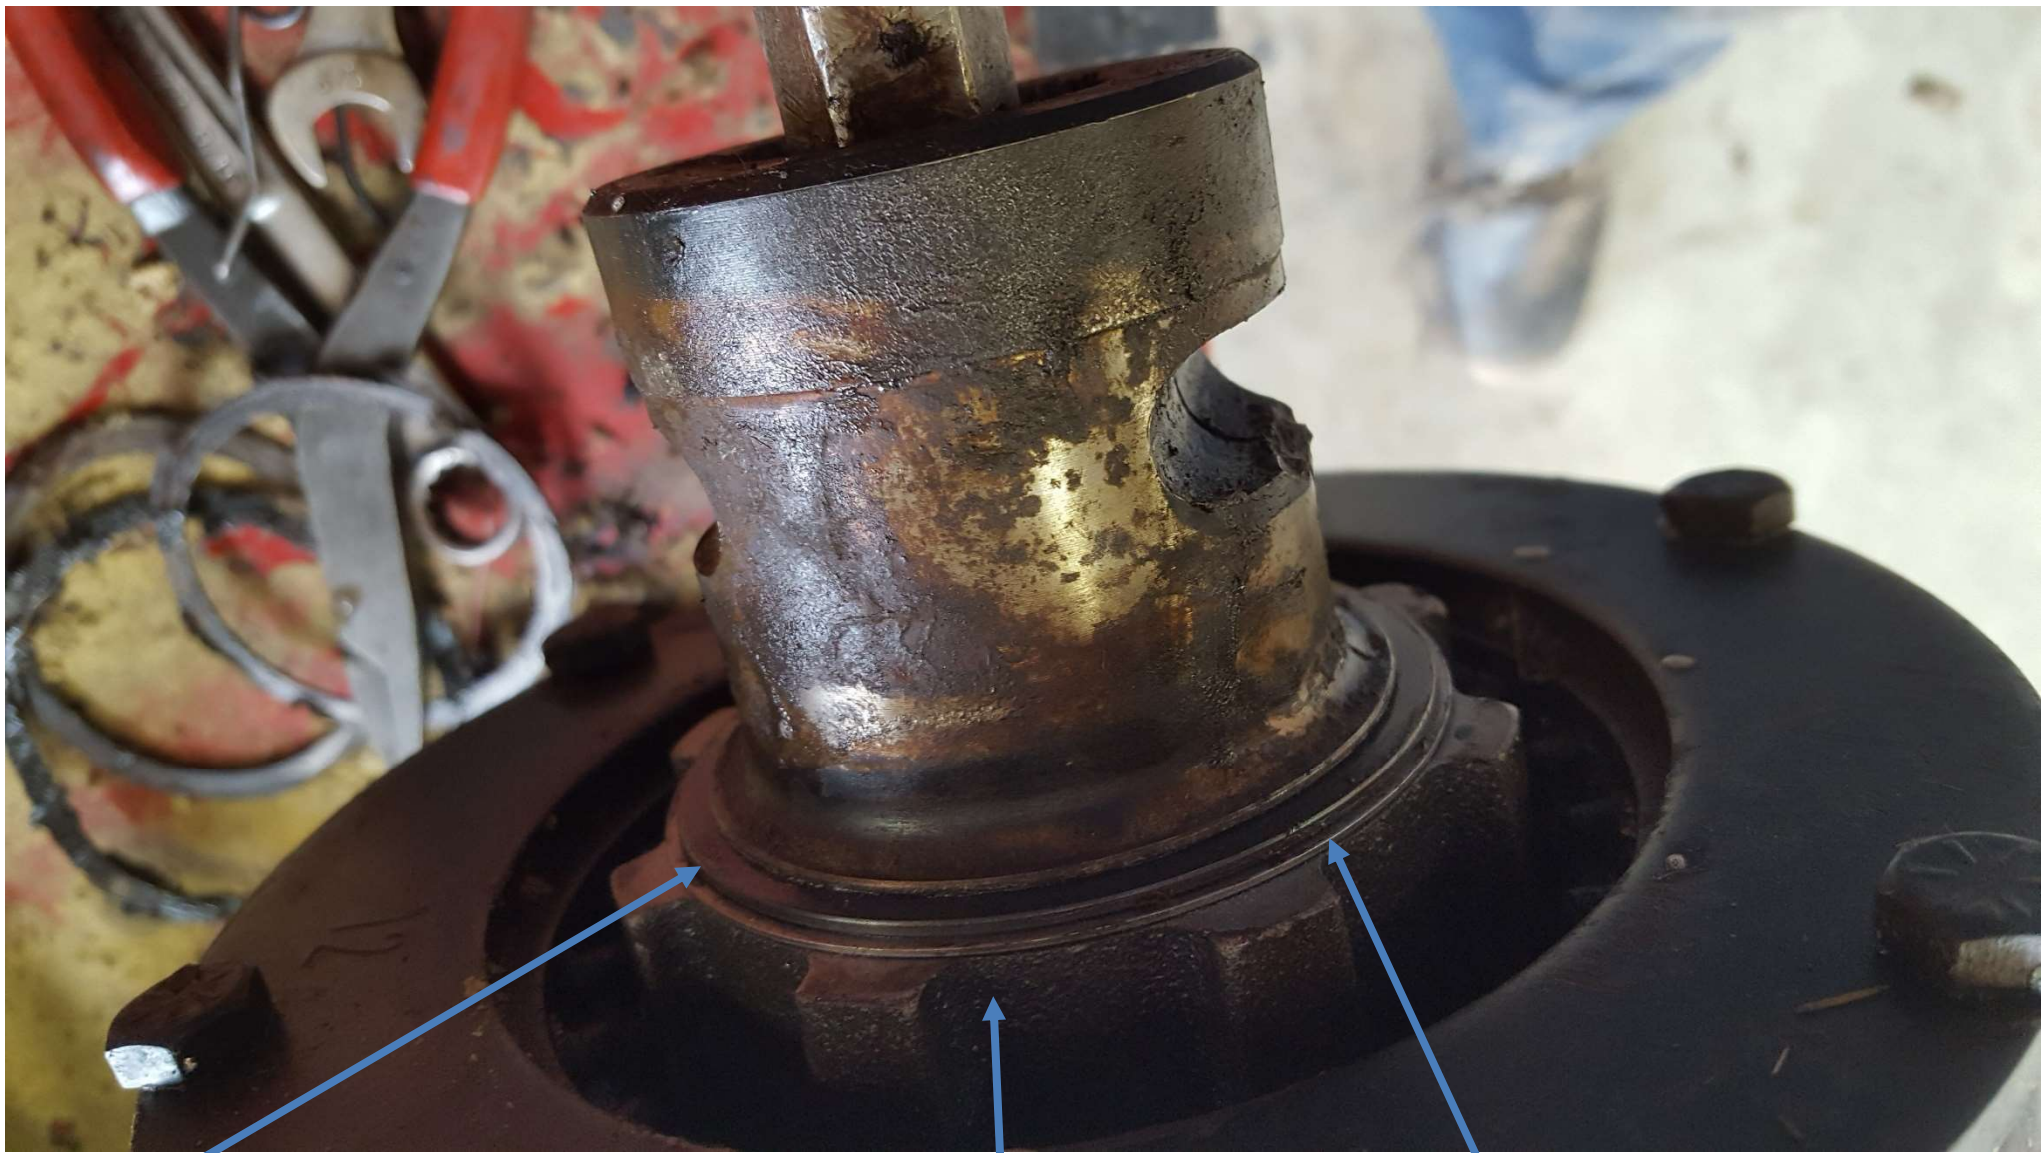
To remove the slip clutch to gain access to the over running clutch, remove the four bolts holding the slip clutch to the yoke. If the machine uses a clamp like in the above photo, the clutch will slide off the center hub when the clamps are removed. If the machine has welded blocks on the end of the center hub, then the slip clutch will need to be dis-assembled and each piece of the slip clutch slid over the blocks. To dis-assemble the slip clutch remove the circle of bolts.

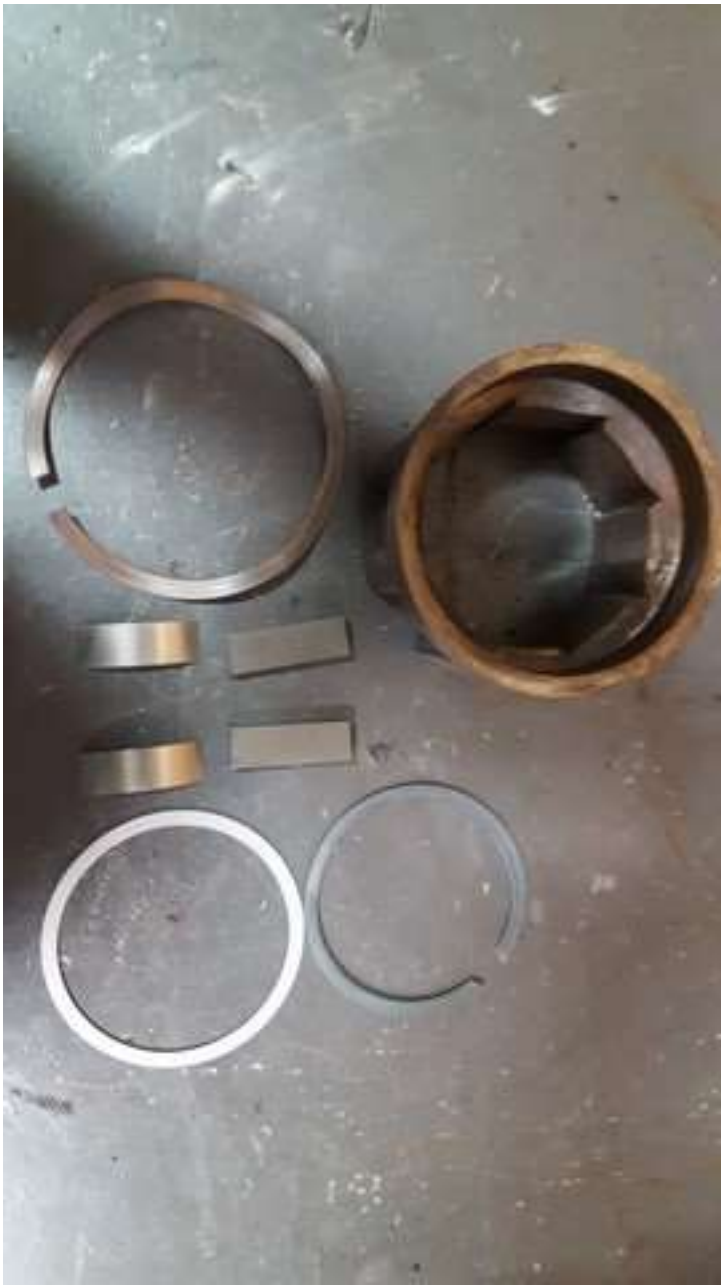
Snap Ring

Hub

Washer Under Snap ring

The hub of the over running clutch is retained by a snap ring. Remove the slip clutch first.

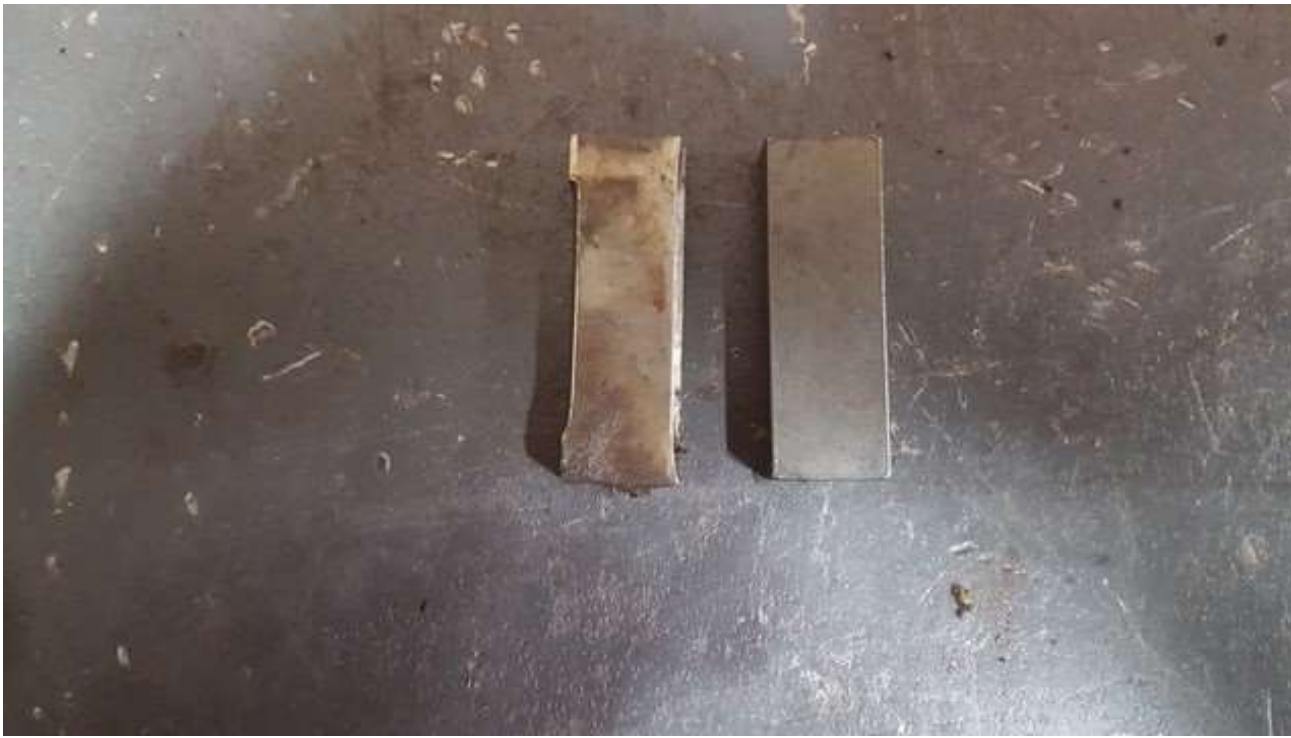
The parts to the over running clutch are shown. The hub is a separate part, but the rest of the parts shown are provided in a kit.

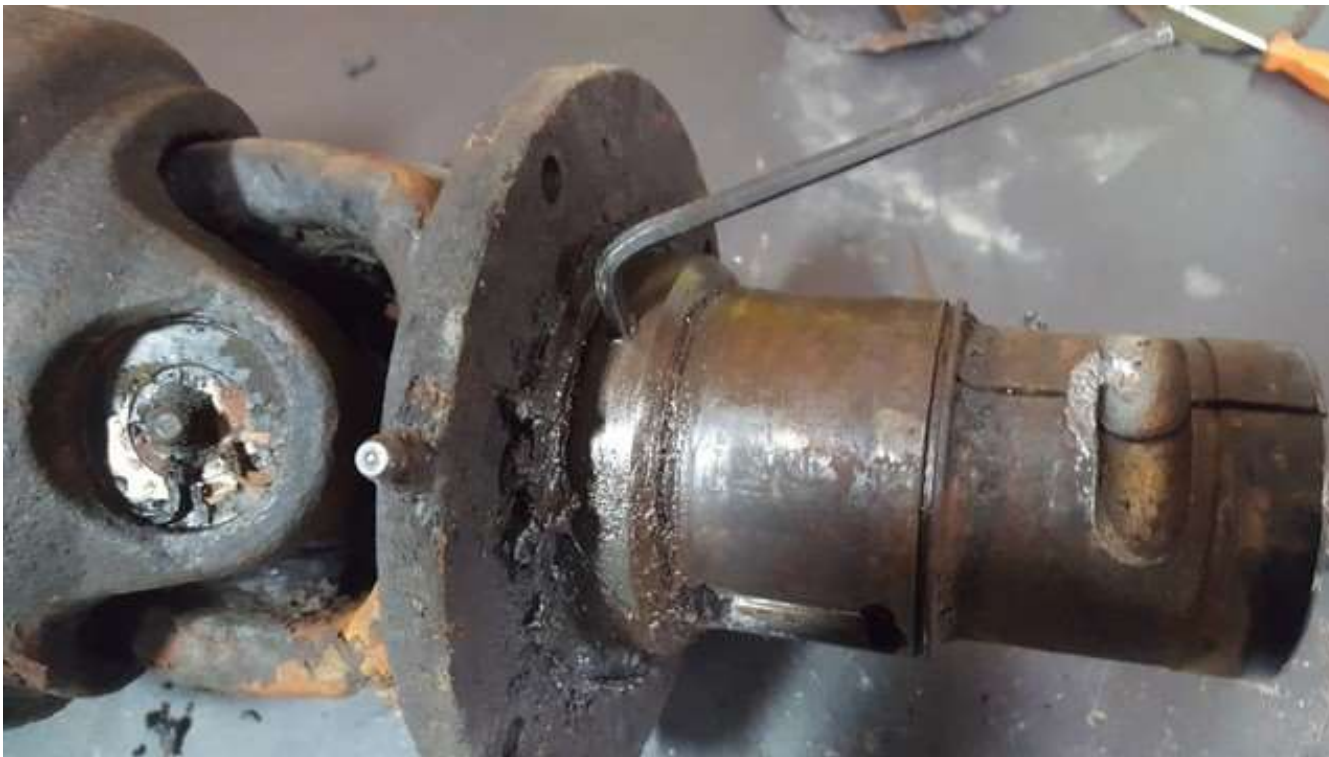
When this style Weasler clutch fails to overrun the cause is likely a worn hub. The internal bore of the hub has smooth ramps the drive lugs rotate against. There should be no grooves or notches in the ramps.

If a notch or groove is present, the drive lug will lock in the groove and cannot rotate up the ramp and freewheel and thus the clutch is inoperative.

A groove has formed and will prevent the over running clutch from working.

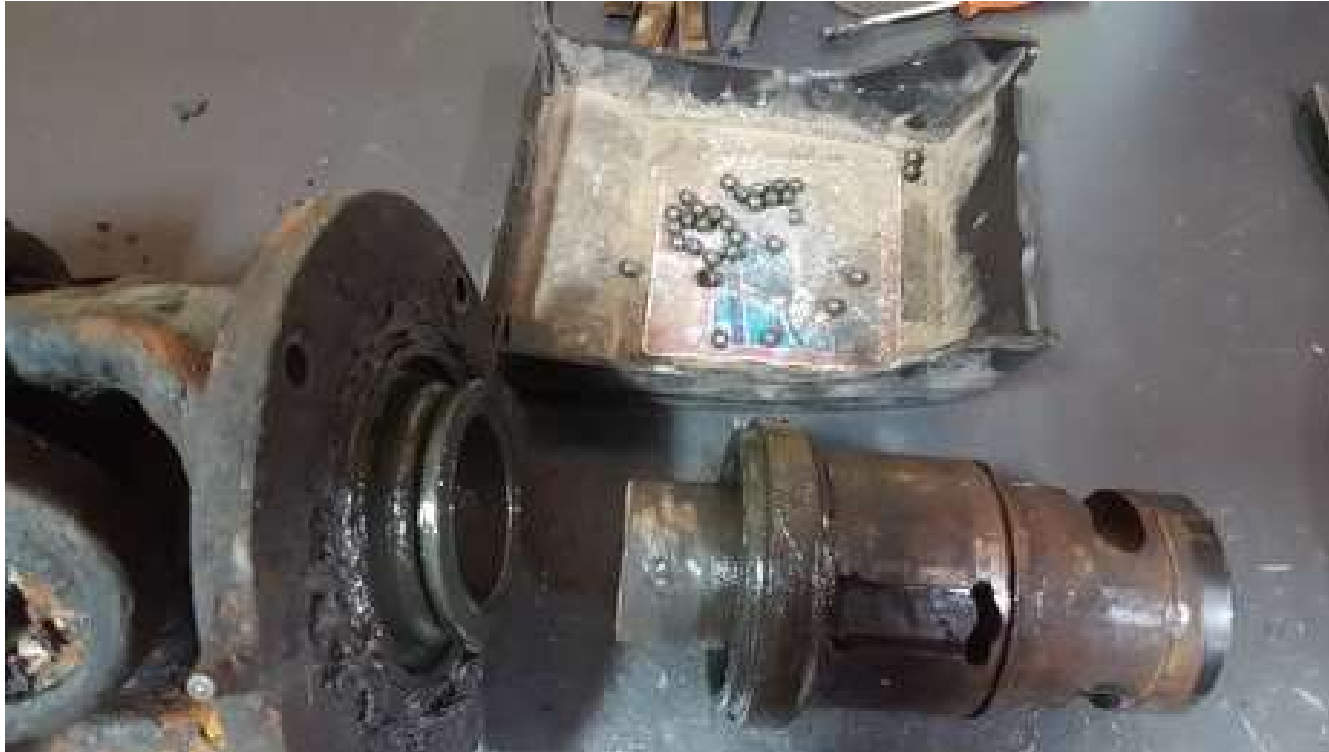
The other part of the over running clutch is the center shaft. It is not necessary to disassemble this portion of the clutch for most repairs.

The shaft rotates independently from the pto shaft. There are 31 ball bearings fitted into grooves in the yoke and the center shaft. To remove the ball bearings and separate the parts, remove the set screw from the center shaft.

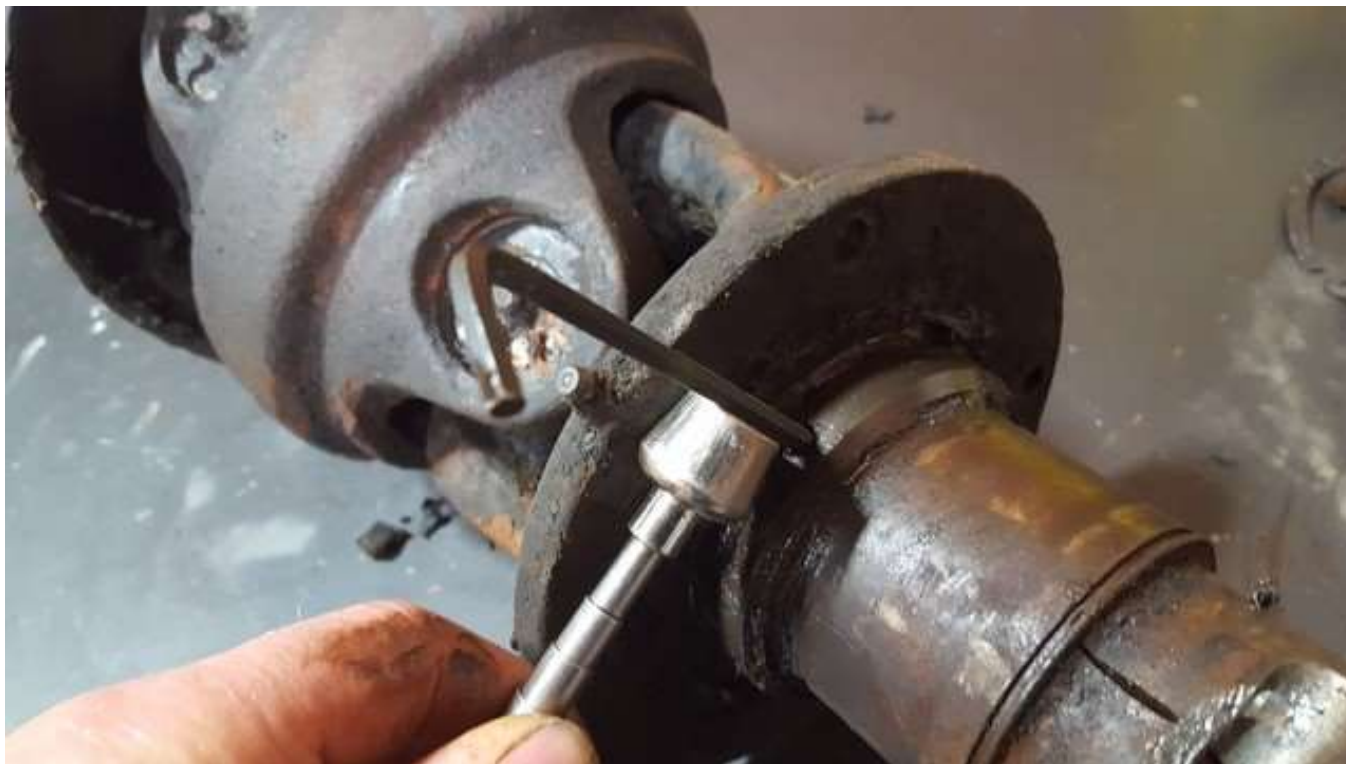
After removing the ball bearings the parts can be separated.

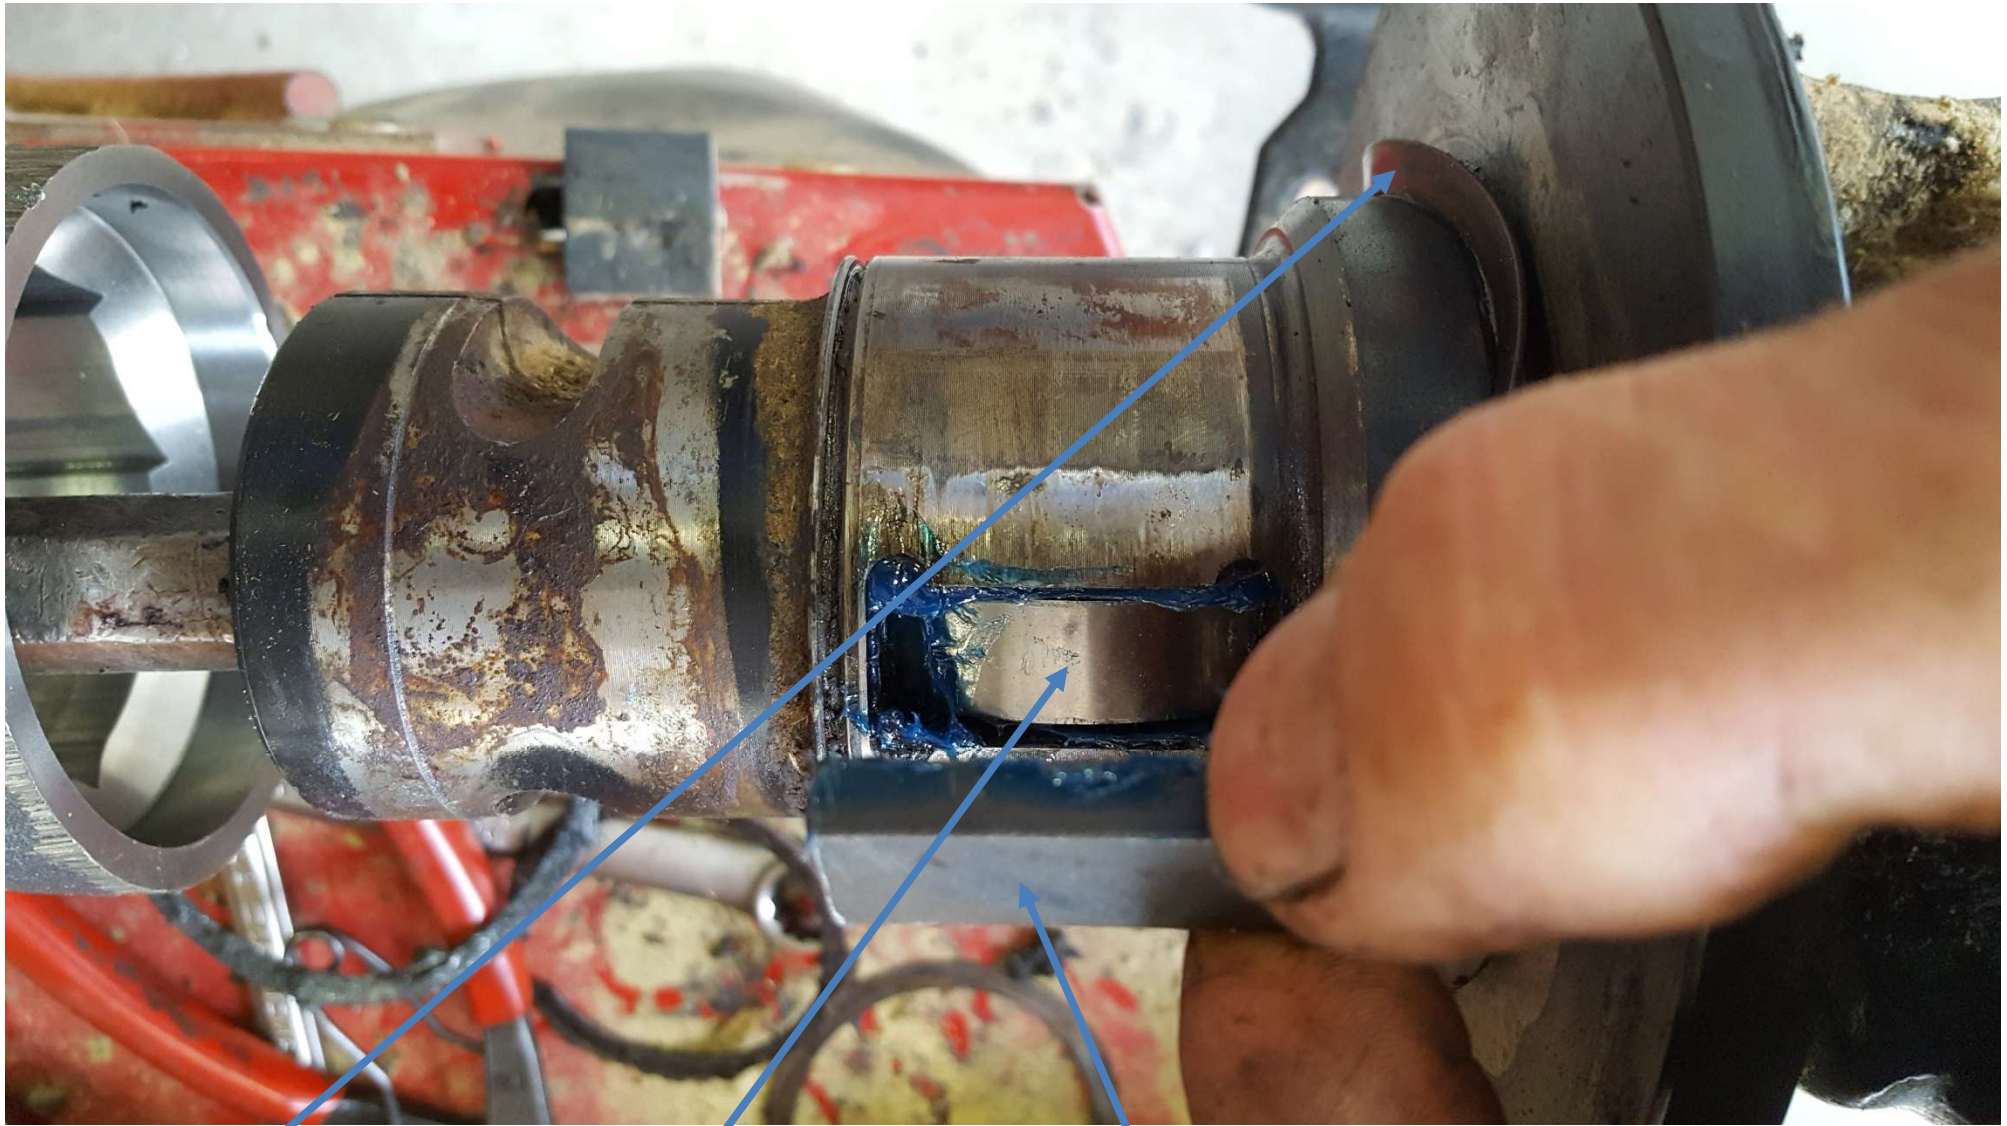
The ball bearings may not fall out on their own. Using a magnet, and in this case the Allen wrench, you can pluck the ball bearings out of the groove.

Wavy Washer

Curved Spring

Drive Lug

On reassembly of the clutch, place the wavy washer on the shaft first. Insert the two curved springs with the hump up in the center of the groove and install the two drive lugs. While compressing the drive lugs into the grooves, slide the drive hub over the drive lugs. Install the washer and snap ring to retain the parts.
